Survey No. SM-371

Maryland Historical Trust State Historic Sites Inventory Form

Name (indicate preferred name) historic DAVIS HOUSE and/or common Location East side of Old Route 5, 1000 ft. north of street & number not for publication Charlotte Hall School Road clty, town Charlotte Hall ____ vicinity of congressional district state Maryland county St. Mary's Classification Category **Ownership Status Present Use** ___ district ___ public ___ occupied _ agriculture museum _ private ___ building(s) __ unoccupied _ commercial _ park ___ structure _ both __ work in progress _ educational _ private residence **Public Acquisition** _ site Accessible entertainment _ religious __ object _ in process _ yes: restricted government scientific _ being considered __ yes: unrestricted _ industrial _ transportation not applicable military no other: **Owner of Property** (give names and mailing addresses of all owners) Maryland Veterans Home Commission name Old Armory Building 11 Bladen Street telephone no.: street & number Annapolis state and zip code Maryland 21401 city, town **Location of Legal Description** courthouse, registry of deeds, etc. liber St. Mary's County Courthouse street & number

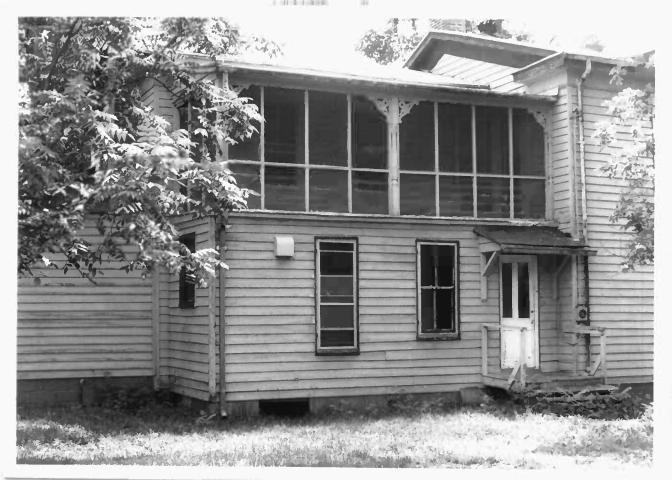
A one bay wide two story porch addition extends along the three northern bays of the two story wing. The first story is enclosed and is used as the kitchen. Each bay of the second story porch is marked by a turned post with jig sawn brackets.

SM-371 Davis House Charlotte Hall, Md. Porch on north facade

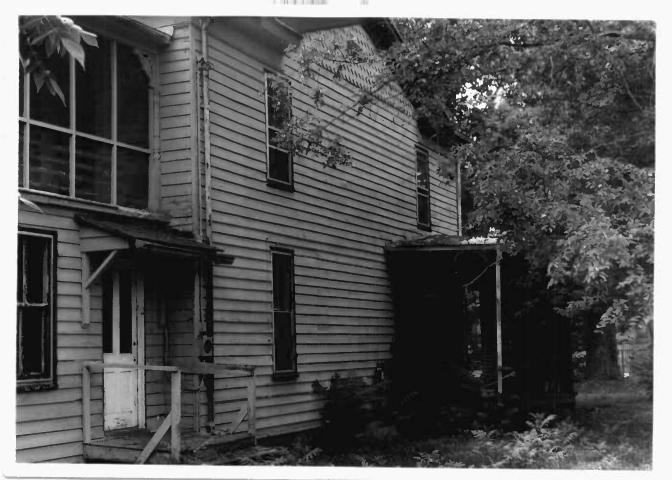
SM-371 Davis House Charlotte Hall, Md. North Facade

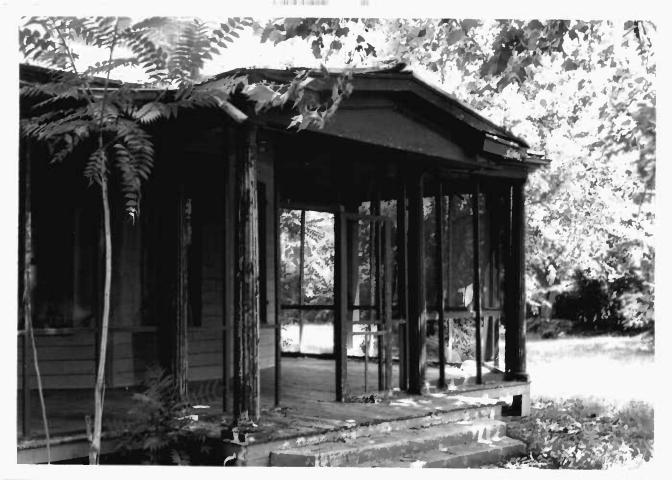
A one story screened porch with diagonal corners wraps around the west, north and south elevations and is supported by fluted Tuscan columns which taper at the top to a narrow capital. pedimented entrance portico with cornice returns is at the center of the west elevation of the porch.

Davis House Charlotte Hall, Md. Detail of porch on west facade

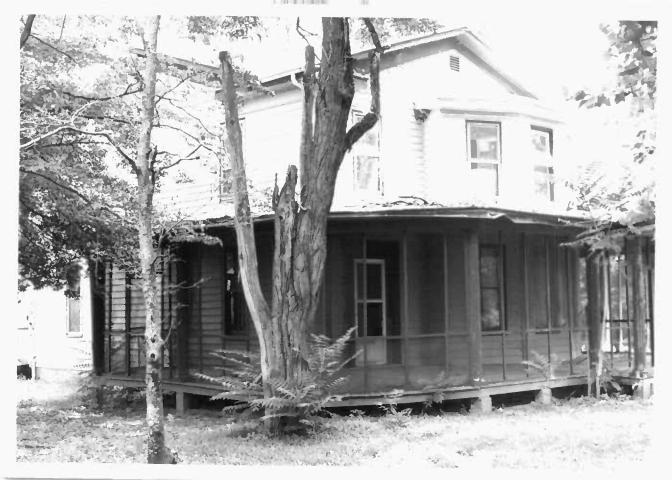
The main section of the Davis House is two and one half stories tall and four bays wide with a cross gable roof. A three sided bay with a pyramidal roof extends from the south end of the west elevation. A boxed cornice runs along all four sides of the frame house and returns at each of the four gable ends. The house is sheathed with weatherboard siding, except for the attic story of the gable ends which are covered with diamond shaped wood shingles.

The main entrance to the house is on the north end of the wes elevation. The door, with four horizontal panels, is framed by narrow sidelights and a transom. The windows on both the first and second stories have either 1/1 or 2/2 sash.

SM-371 Davis House Charlotte Hall, Md. West Facade

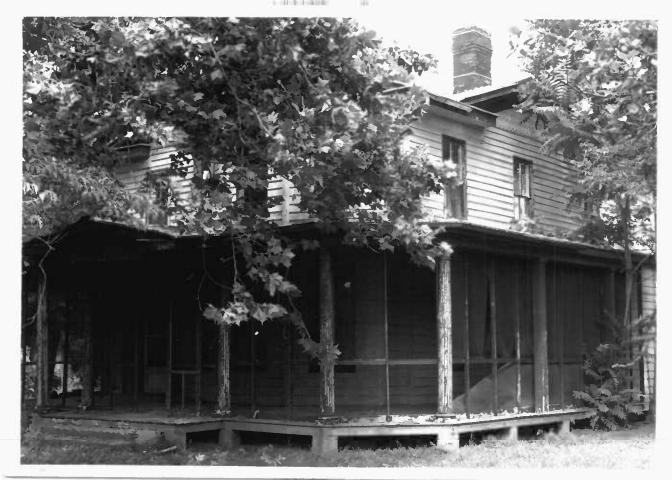
SM-371
Davis House
Charlotte Hall, Md.
Southwest elevation
Geoffrey Henry
Negatives at MHT

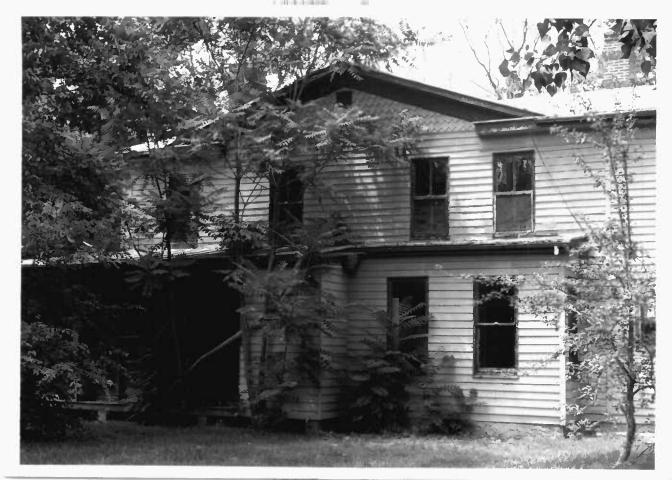
SM-371
Davis House
Charlotte Hall, Md.
South elevation
Geoffrey Henry
Negatives at MHT

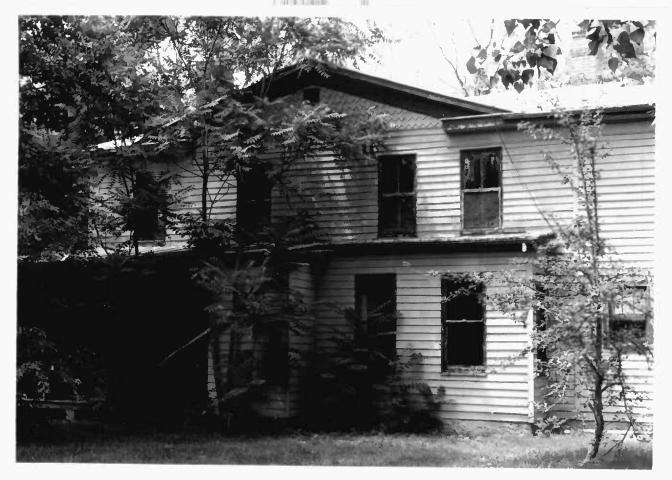
SM-371
Davis House
Charlotte Hall, Md.
South elevation
Geoffrey Henry
Negatives at MHT

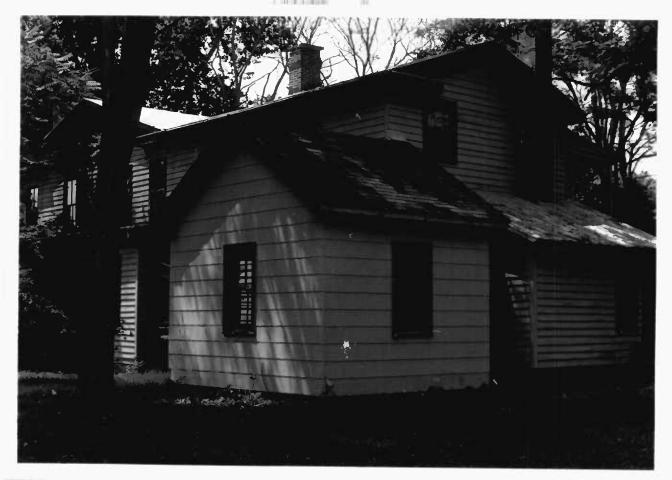
A two bay wide and three bay deep gable roofed wing extends from the east elevation. It also has a boxed cornice with returns on the gable end. There is a small entrance with a hood roof on the north elevation. A one bay wide and one bay deep gable roofed addition extends from the south-east corner of this wing. The addition is covered with asbestos siding and has 6/6 sash windows.

SM-371 Davis House Charlotte Hall, Md. SE Corner
